DEPARTMENT OF TRANSPORTATION

Contract #: 04-0120F4Cty: SF/ALA Rte: 80 PM: 13.2/13.9File #: 69.28**WELDING INSPECTION REPORT****Resident Engineer:** Pursell, Gary**Address:** 333 Burma Road**City:** Oakland, CA 94607**Report No:** WIR-003846**Date Inspected:** 06-Sep-2008**Project Name:** SAS Superstructure**OSM Arrival Time:** 700**Prime Contractor:** American Bridge/Fluor Enterprises, a JV**OSM Departure Time:** 1700**Contractor:** Zhenhua Port Machinery Company, Ltd (ZPMC), Changxing Island **Location:** Shanghai, China**CWI Name:** Sun Wei**CWI Present:** Yes No**Inspected CWI report:** Yes No N/A**Rod Oven in Use:** Yes No N/A**Electrode to specification:** Yes No N/A**Weld Procedures Followed:** Yes No N/A**Qualified Welders:** Yes No N/A**Verified Joint Fit-up:** Yes No N/A**Approved Drawings:** Yes No N/A**Approved WPS:** Yes No N/A**Delayed / Cancelled:** Yes No N/A**Bridge No:** 34-0006**Component:** OBG and Tower**Summary of Items Observed:**

OBG Sub-Assembly Bay 1

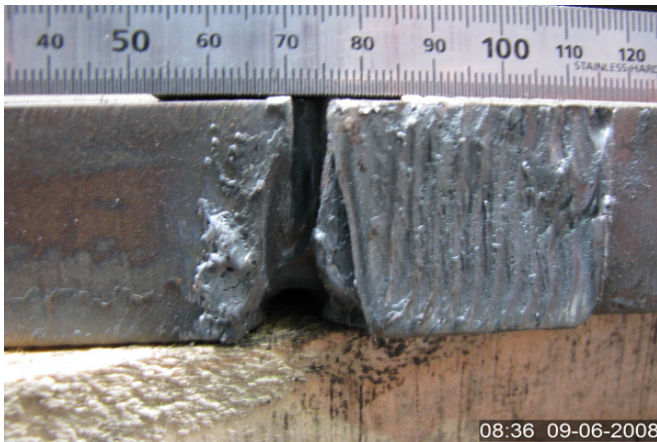
The Quality Assurance Inspector observed ZPMC performing fit-up and tack welding operations to Deck Panel DP-550-001 utilizing the gas metal arc and flux cored arc welding process. This panel is designed with closed ribs and plate stiffeners. On several of the five plate stiffeners, numerous torch notches were observed on the cut edges.

ZPMC relayed they would blend the torch notches that were less than 5 millimeters in depth utilizing a grinder and perform weld repairs to notches greater than 5 millimeters in depth. Below is a digital photograph illustrating a torch notch measuring approximately 10 millimeters in depth.
